# Manhole Inspection Summary

Manhole # S11Y\_\_013MH

Insp Date: **5/6/09 9:36 AM**

**Location** Address: **3400 BENSON AV**

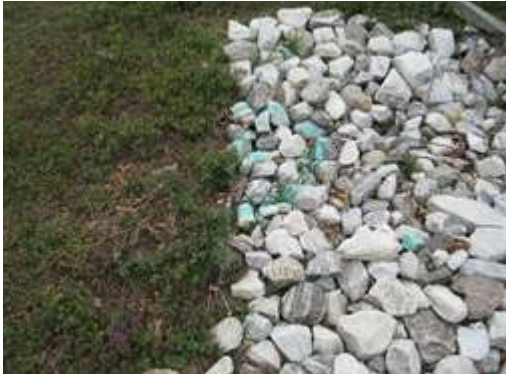
Miscellaneous

MH was buried under rocks

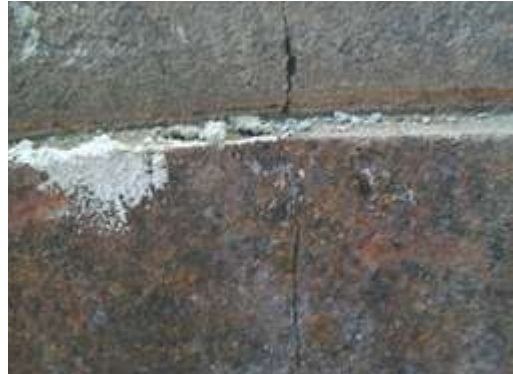
Defect 1

**Frame** Offset: **0** (in.) Condition: ☐ Sound ☒ **Cracked** ☐ Leaks

CRACK IN CASTING

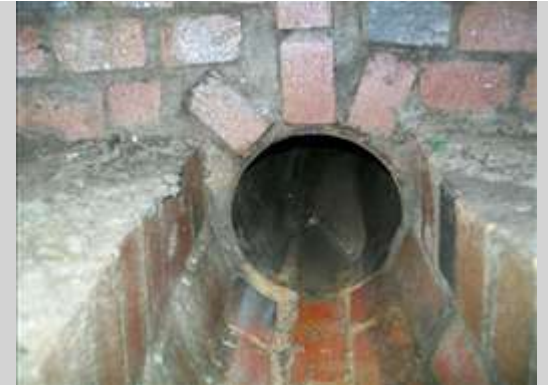
12 O'Clock Outflow

8 in. Circular Gravity Sewer  
Pipe Out @ 12 O'Clock

Infiltration: **None** Pipe Seal Cond: **Sound**

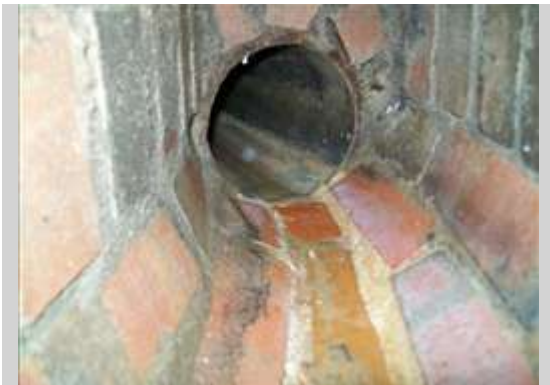
5 O'Clock Inflow

8 in. Circular Gravity Sewer  
Pipe In @ 5 O'Clock

Infiltration: **None** Pipe Seal Cond: **Sound**
